February 14, 2006

Honorable Mayor and Members of
the Hermosa Beach City Council

PIER DECK CONCRETE COATINGS – INSTALLATION OF SURETREAT TOTAL PROTECTION SYSTEM

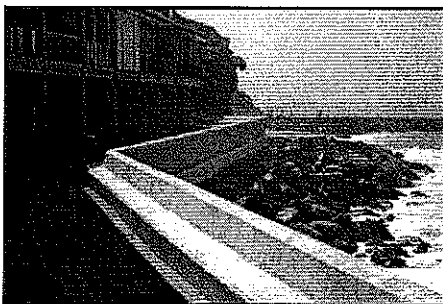
customer	Blue Lagoon Condominiums
location	Laguna Beach, California
structure	Seawall
date performed	2003

The Blue Lagoon Condominium seawall has had constant exposure to the extreme environment of the Pacific Ocean. The result of this has been the contamination of the wall by chlorides (Sea Salts) and other air/water borne contaminants. While the wall was in fairly good shape, cracks have begun to form and there was disbonding of the overlay. While the cracks were not prevalent through the entire wall they did represent a direct pathway for moisture and contaminants to infiltrate the structure and reach the reinforcing steel.

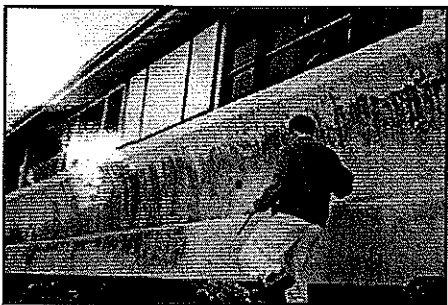
Once the seawall had been properly cleaned and repaired, the first formulation was applied. This formulation travels in a vapor phase and was applied by use of a pressure fed roller and sprayer. It was designed to reestablish the protective film at the reinforcing steel level. The second formulation was designed to penetrate the concrete anywhere from 2-4 inches penetrating and reacting with the cement paste and gel pores to decrease porosity, control pH, extract and displace chlorides and provide an additional layer of protection at the rebar level. Spray units and pressure fed rollers were used to apply the 2nd formulation.

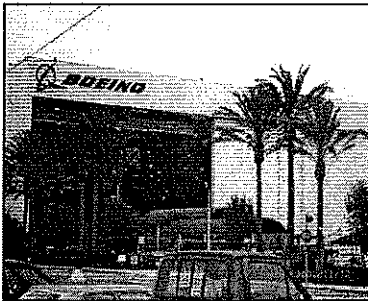
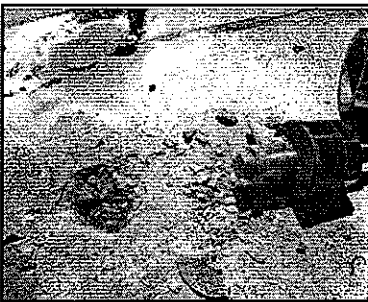
customer	Boeing
location	Long Beach, California
structure	Ramps
date performed	2001

Random fine cracks have developed on these 13 inch thick concrete assembly ramps as a result of the loading and unloading of C-17 aircraft taxiing across them over time. The cracks have enlarged, and additional small cracks have propagated from them. These cracks lead to the formation of concrete fragments, foreign object debris (FOD), which can become airborne and have the potential of being sucked into jet engines causing major damage to the aircraft.

The SURTREAT® process involved the surface application of chemical formulations, which penetrate the surface to a minimum depth of 2 inches, and react with the cement phase to increase strength, decrease porosity, and inhibit rebar corrosion and cement chemical degradation.

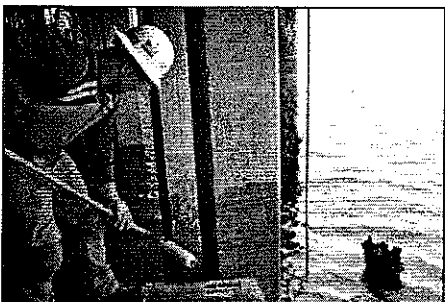
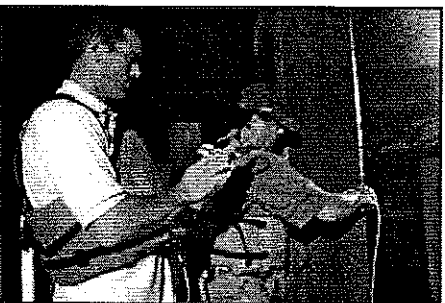
customer	Port of Hueneme
location	Port Hueneme, California
structure	Pier Piles
date performed	April, 2004

Built in the 1960's, several of the 61 piles supporting the main dock at the Port of Hueneme in Oxnard, CA were showing signs of deterioration and corrosion. Due to the 40 plus years in the harsh Pacific Ocean environment, the piles were in need of a combination of concrete repair, fiber reinforcement and corrosion inhibition by way of using Surtreat's proprietary corrosion inhibition formulations.

Surtreat prescribed three formulations which were applied to 61 piles from the underside of the deck. The application took 3 days due to the tide schedule and was completed on April 21st, 2004. Our Total Performance System first included one application of TPS XII. TPS XII is an anodic vapor phase corrosion inhibitor designed to migrate to the reinforcing steel and form a passivating film around the steel surface. Subsequently, two applications of TPS II, a mixed use corrosion inhibitor, were applied. This formulation will also mitigate corrosion but additionally it will reduce porosity, buffer pH, increase strength and reduce water-soluble chlorides. Finally, a single application of TPS IV was applied to further reduce surface porosity and increase surface hardness.
